Bahagian 3 : Penjelasan Mengenai TOR

Term Of Reference – The Forensic Engineering Services (Slopes & Slopes Related Structures) And The KISB Services

TERMS OF REFERENCE THE FORENSIC ENGINEERING SERVICES (SLOPES & SLOPES RELATED OF STRUCTURES) AND THE KISB SERVICES

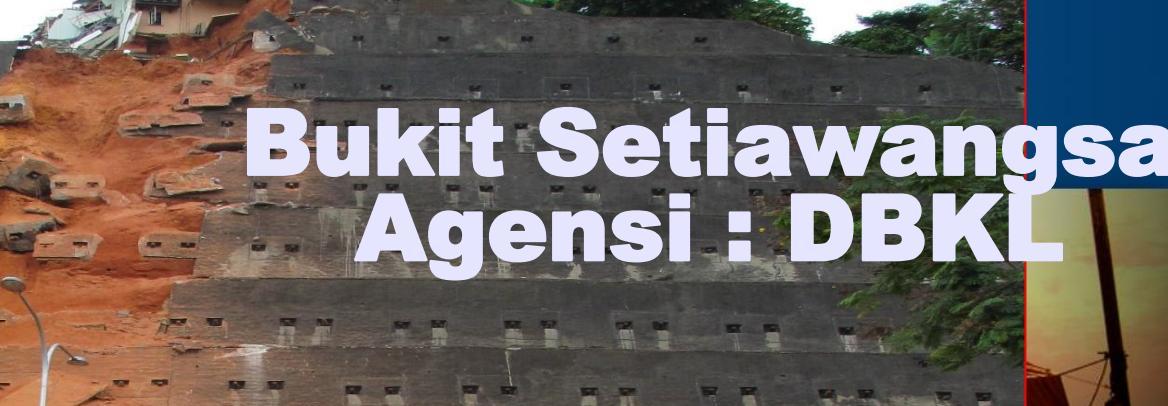
Thick Overburden (Silty Material)

H = 50m

$\alpha = 70$

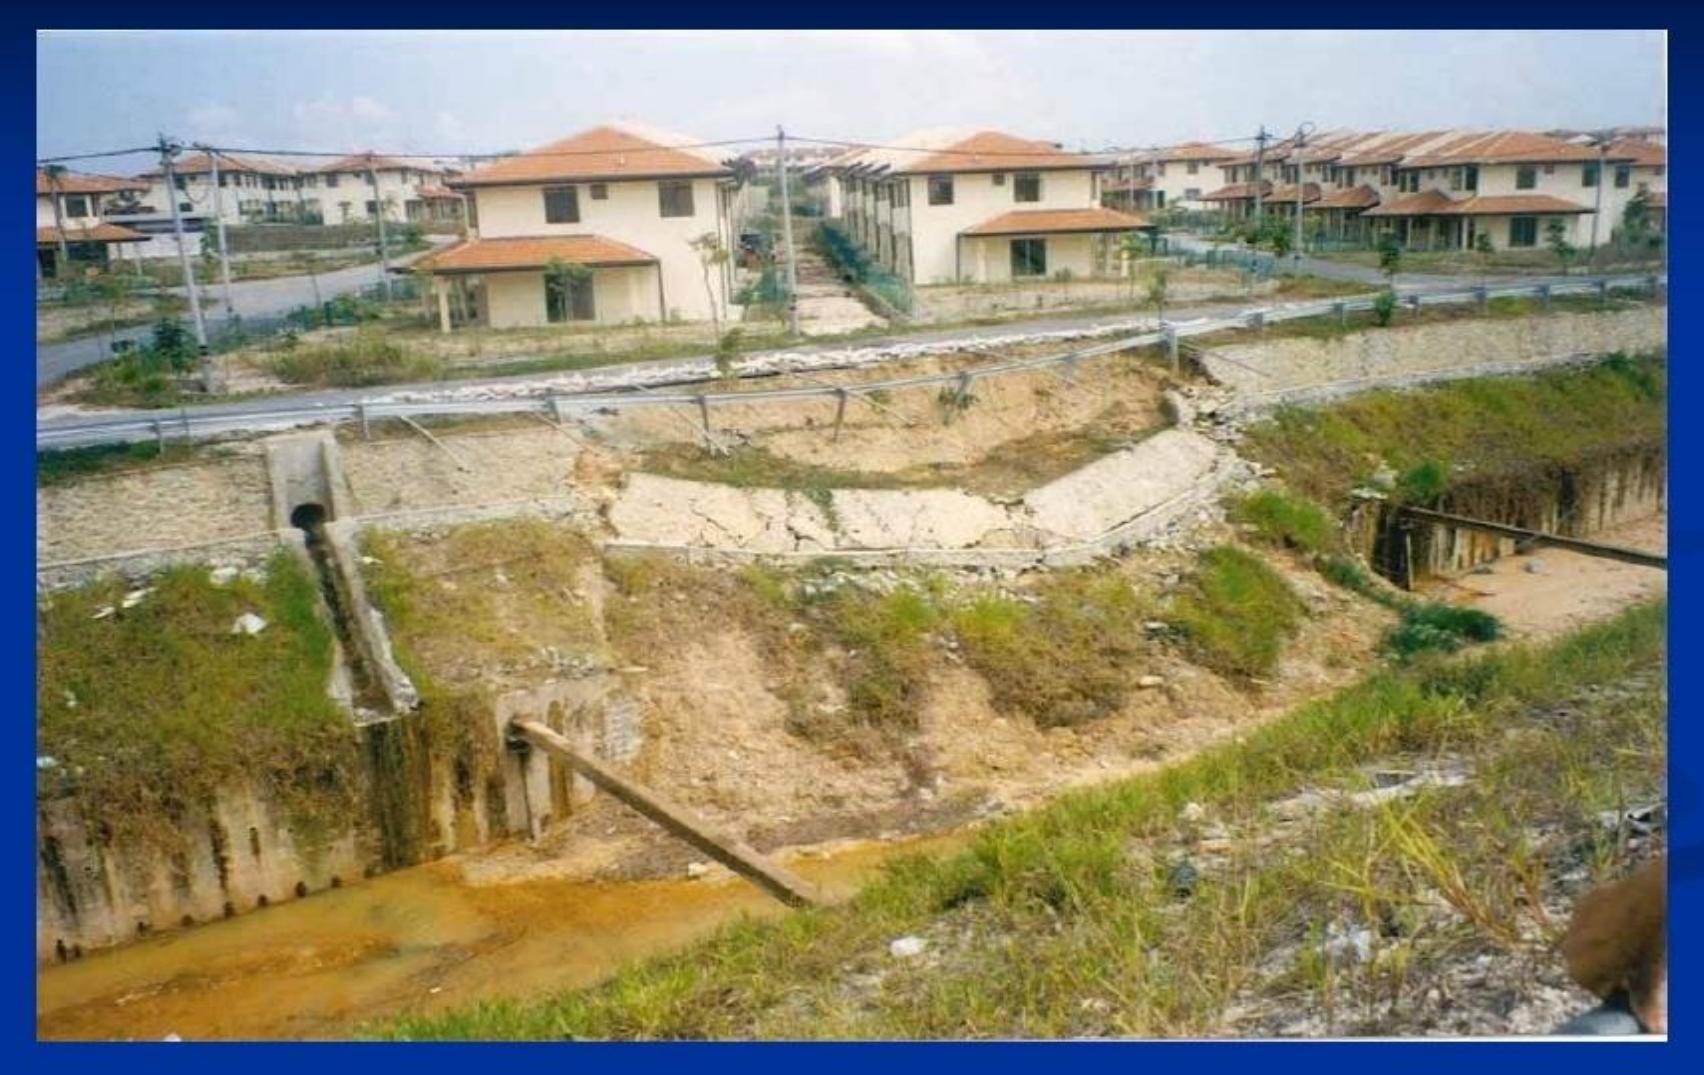
RC Wall Failure

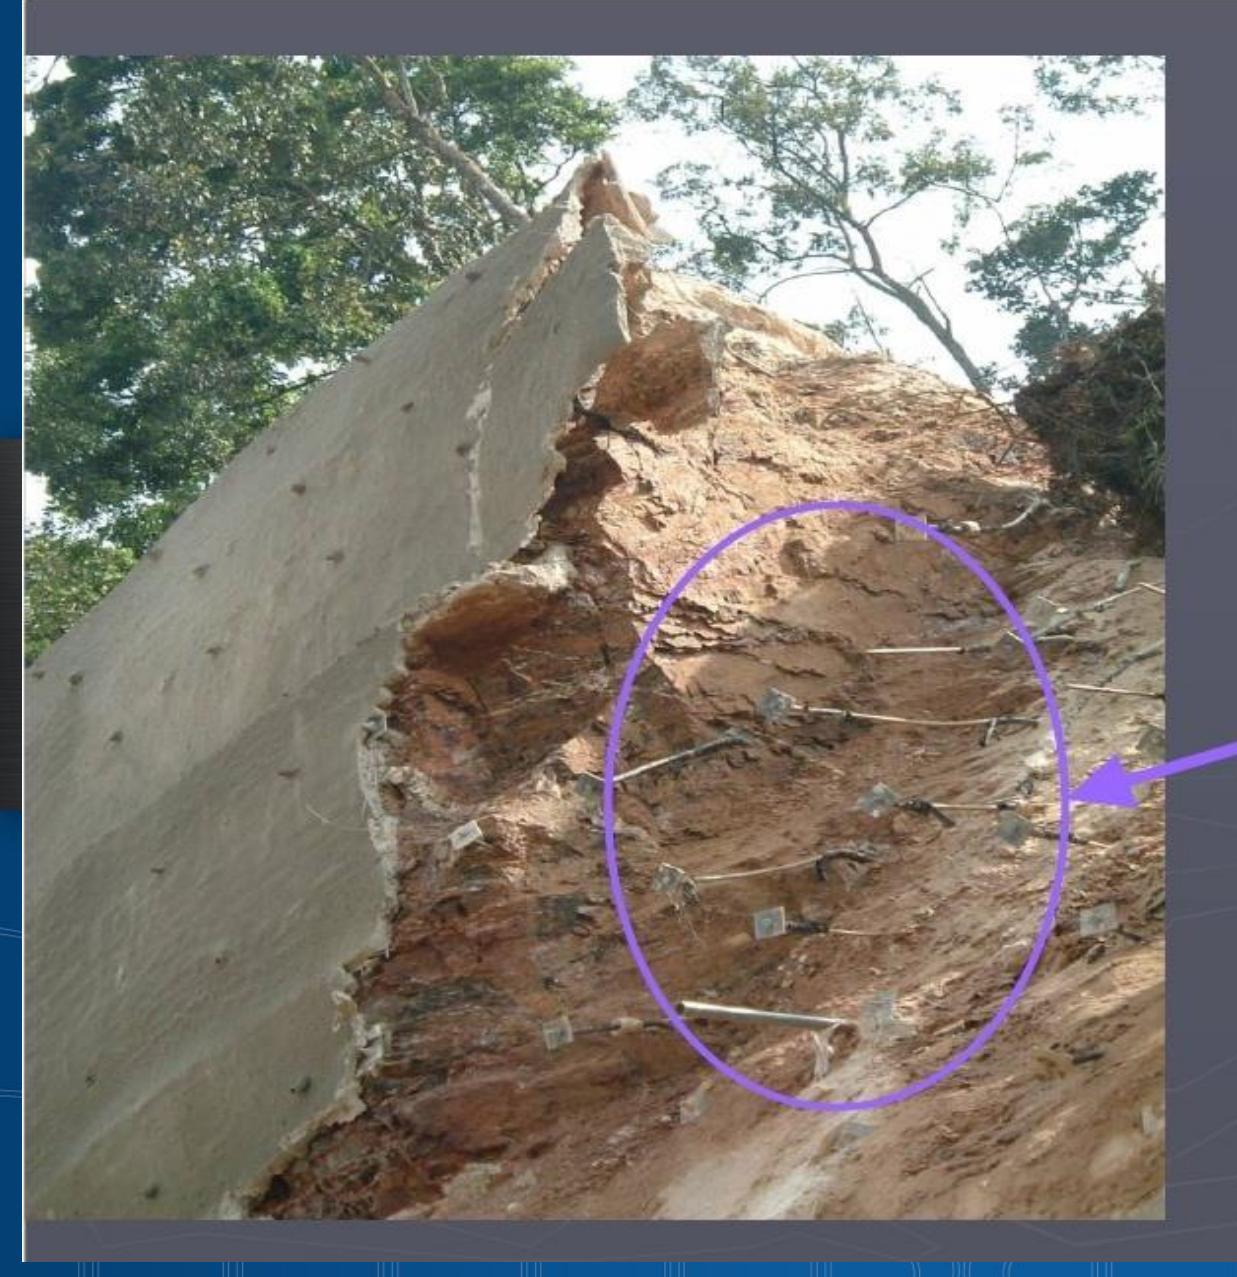
RE Wall Failure

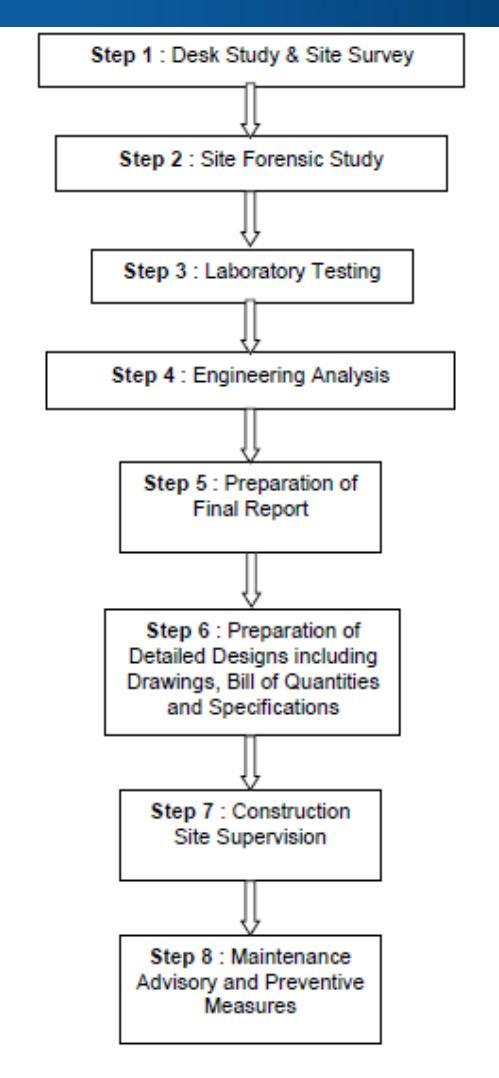
Figure 5.2 :Generic Steps in the Forensic Engineering Investigation (Slopes & Slope Related Structures)

- * 5.2 STEPS IN FORENSIC
 ENGINEERING INVESTIGATION
 (SLOPES & SLOPE RELATED
 STRUCTURES)
- The generic steps in the Forensic
 Engineering Investigation (Slopes
 & Slope Related Structures).

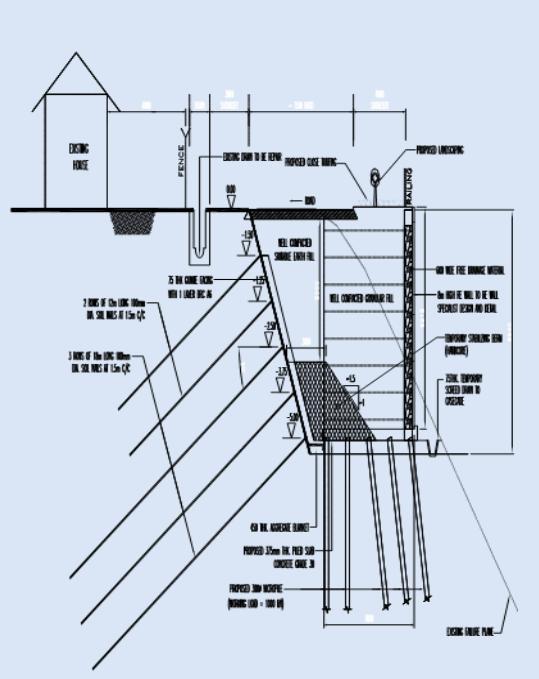
SECTION AT CH 30.00

- 5.2.4.1 Engineering analysis shall be carried out to determine the prevalent soil / material properties at failure of the slopes.
- 5.2.4.2 The steps to be undertaken during this step for slope failure shall include:
 - * a. Slope stability back analyses on the failed slope
 - b. Slope stability analyses for remedial works
- * 5.2.4.3 Remedial Design for Failed Slope

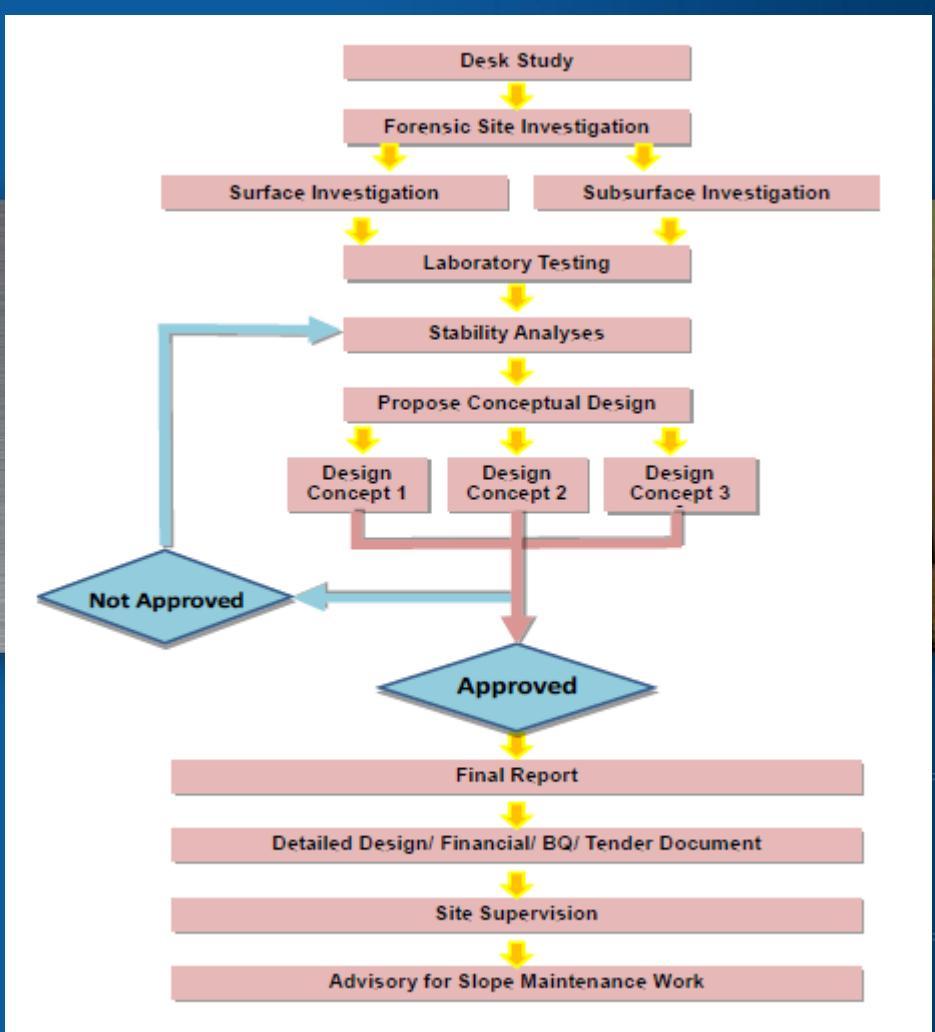
For non - emergency events, the methodology for the implementation of Forensic
 Engineering Investigation (Slopes & Slope Related Structures) shall be undertaken in the following flow chart.
